Building Inspection Report

127 Main St, East Hartford, CT, 06108

Inspection Date:
7/3/15

Report Number:
703151

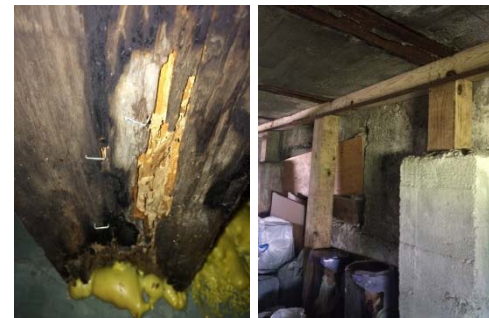
- **Major Concern:** The front concrete porch exhibited cracking and movement observed at the porch and below the porch. Some repairs have been made however it was determined if they are adequate. Recommend further evaluation by a licensed qualified foundation contractor or engineer.
- **Major Concern:** Evidence of wood destroying insect damage was observed and there is risk of additional hidden damage since termites and carpenter ants can do a substantial amount of damage. If the property has not already been treated, a licensed pest control specialist should be engaged to eliminate further wood destroying insect activity within the home and garage. Damage was noted to the main beam in the basement and to the sill plate in the detached garage. Allow for termite and carpenter ant treatment and repairs to the damaged wood.

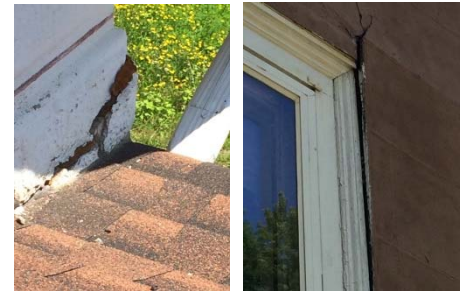
- **Major Concern:** The stucco wall surfaces show evidence of significant deterioration. These areas are at risk for hidden damage. Allow for further evaluation and repairs by a licensed qualified contractor.
- **Safety Issue:** For improved safety, a handrail should be installed at the front exterior stairs. Install a handrail as required.
- **Repair:** The old windows are in need of glazing (putty) improvements. Several broken windows were observed. The windows should be repaired as required. Replacement windows may be the best long term approach.
- **Repair:** The garage door opener is inoperative. It should be repaired or replaced as necessary.
- **Safety Issue:** No safety cables were noted on the garage door springs. The installation of the cables would improve safety during operation. The overhead garage door has a broken spring. Allow for repairs as needed.

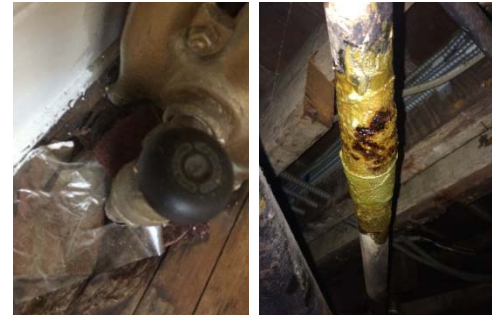
- **Repair:** Radiators in the dining room and second floor bedroom appear to leak. Damaged heating pipes were observed in the basement. The radiators and heat pipes should be further evaluated and repaired as necessary by a licensed qualified contractor. Damage to the flooring and ceiling should from radiator leaks should be repaired.
- **Safety Issue:** An odor of gas was noted at the boiler burner. A licensed qualified heating contractor should be engaged as soon as possible.
- **Repair:** The heating system requires service. This should be a regular maintenance item to assure safe, reliable heat. Based on its age the boiler is near the end of its life.
- **Safety Issue:** The chimney serving the gas fired heating system does not appear to be properly lined. Have the chimney inspected and lined (if necessary) by a licensed qualified chimney sweep.
